CHURCH MONUMENT HANDBOOK

TIPS FOR IDENTIFICATION, CARE AND REPAIR

Minerva Stone Conservation Ltd

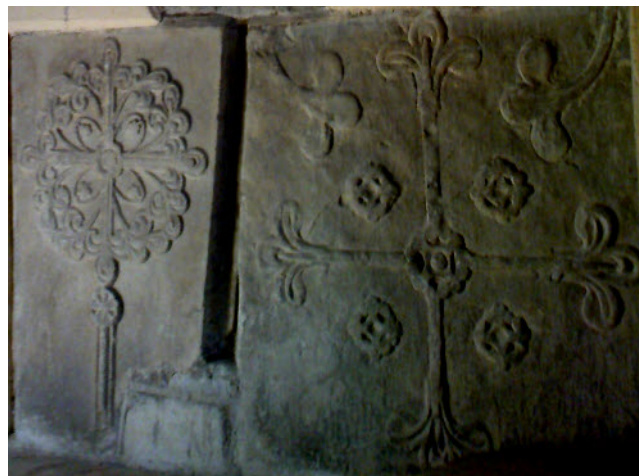
Above: fragments of early 13 century Blue Lias grave coverings with stiff leaf detailing, Limington, Somerset).

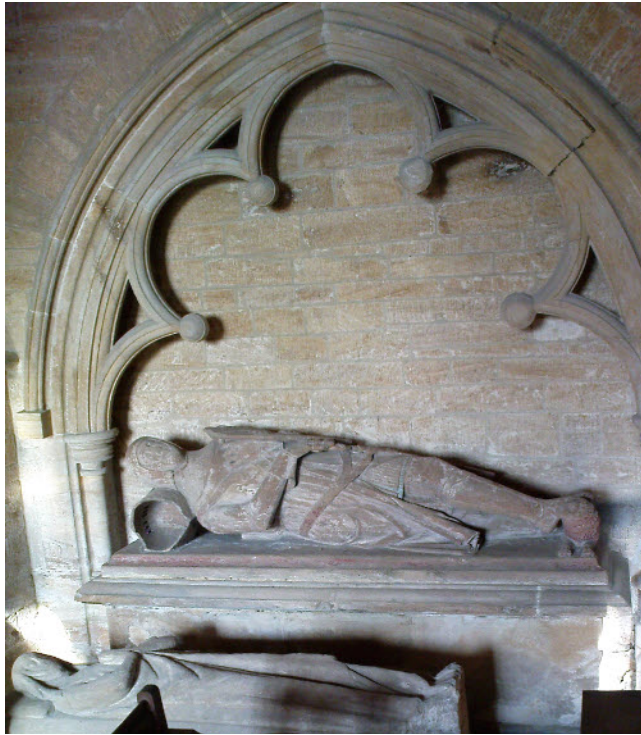
Left. Effigy of Sir Richard Gyvernay, Limington, Somerset.

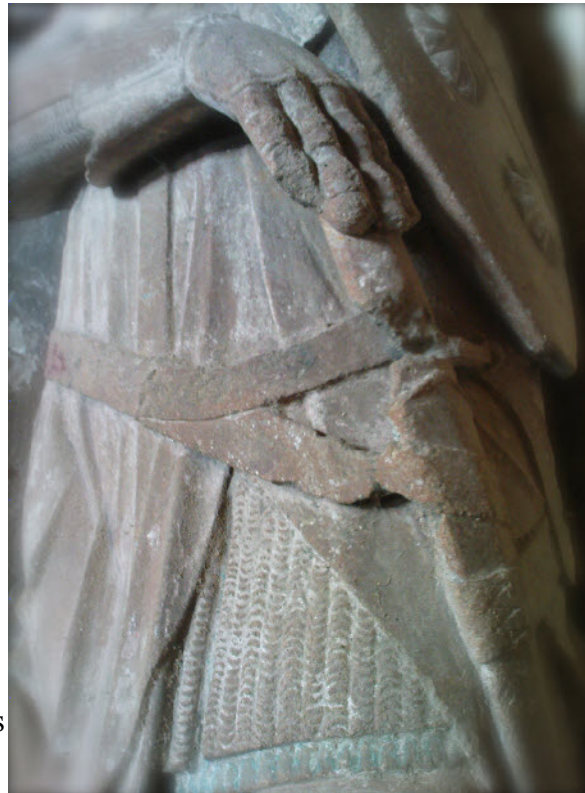
The variation and development from the simple stone slab to the most elaborate canopy tomb is too complex to be explored here. However, beside freestanding chest tombs, canopied recesses in church walls also housed effigies, usually on a decorated base and plinth. Early, rudimentary, low-relief, horizontal portraiture developed into full high-relief recumbent effigies. Many knightly effigies were created between 1240 and 1330. The armour-clad and richly coloured effigy of Sir Richard Gyvernay, c1320, is carved from a single piece of local Ham stone of excellent quality.

The message that he was a warrior is nothing more than spin. Instead of being depicted in prayer the mason has him posing in extravagant gauntlets, but there is no record of him as other than a shire landowner. The shield motifs exist on no rolls of arms and this forms part of the mystery associated with this tomb.

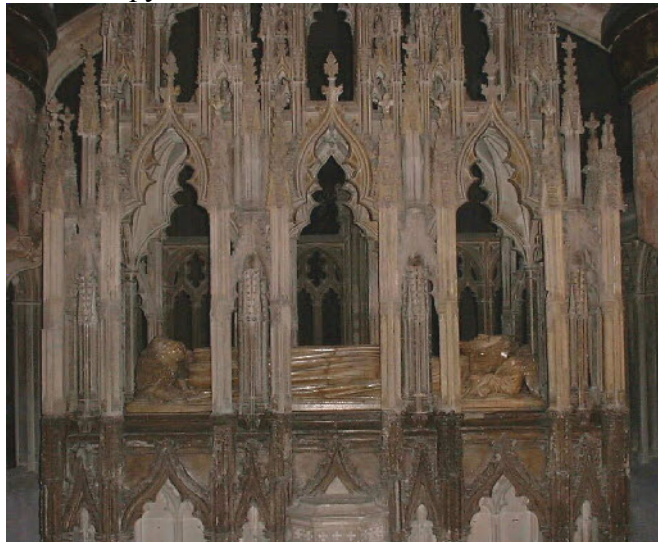
The Canopy tomb

Box tombs with an effigy may be further embellished with a canopy in masonry or, on occasion, in wood. The canopy may be free standing on vertical shafts or cantilevered from a wall. In the latter case an iron armature may be found within the canopy to replace the strength of the shafts. This may be a result of an "improving", although now often corroding intervention in the 19th century. Missing or damaged architectural details may have been replaced

in stone, wood or plaster and may have been fixed with ferrous dowels. A number of the elaborate finials at the tomb of King Edward II, Gloucester Cathedral, are replacements from subsequent periods, including the 21st century.

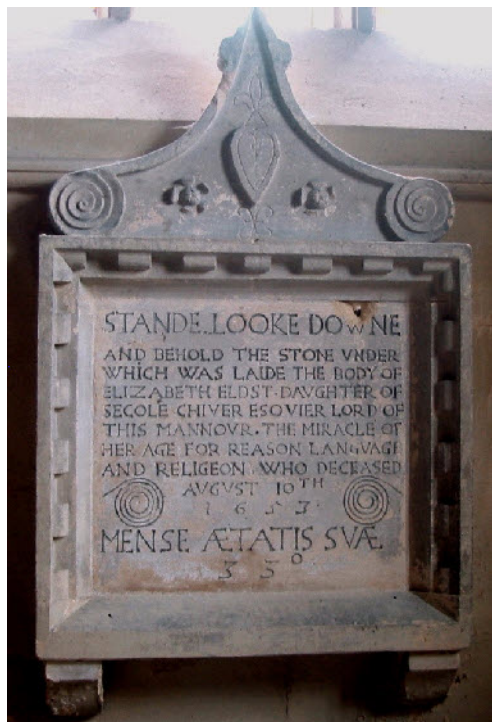
Left: The effect of corroding iron cramp is evident from the “scalloped” fracture at the top right hand corner of the inscription slab.

Problems in monuments positioned at height can often be overlooked. The simple process of the corrosion of iron fixings will always be challenging to manage and may at some time require some form of attention. Rusting ironwork may just need monitoring but iron can increase in volume by up to 80% causing associated stonework to fracture and crack. Once equilibrium is upset the monument can become structurally unsound. Cathodic protection (passing a small electrical current through ironwork to prevent further corrosion) is sometimes cited as a corrosion cure but is rarely appropriate in churches.

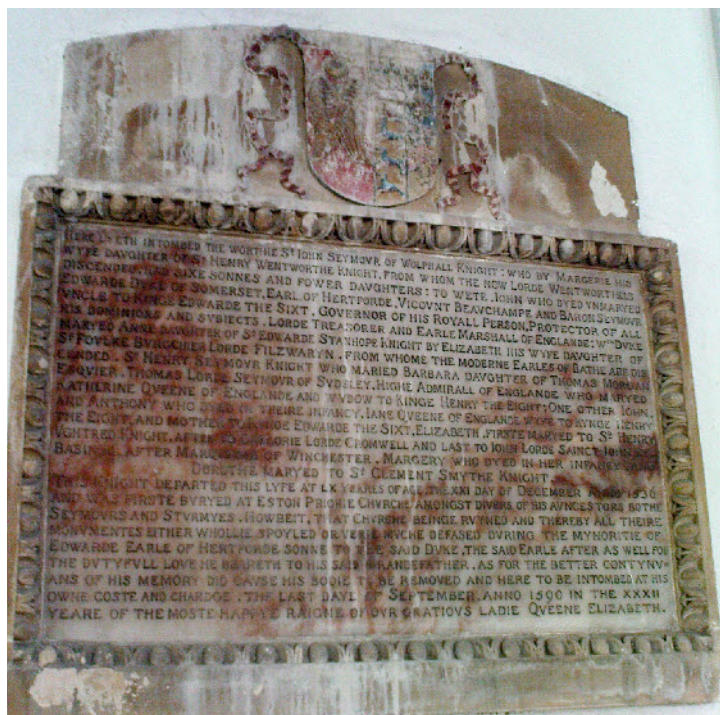
Above: The irreversible damaging effect of water streaking is evident on this alabaster monument.

As monuments do not have damp proof courses, moisture is always present . Water is drawn up into masonry walls from the ground and evaporates through the lime joints in the stonework (and thus also to ferramenta). This passage of moisture can also carry damaging soluble salts such as sulphates, nitrates, phosphates and, at the coast, chlorides. Internally, where there has been a change in equilibrium (flooding, a leaky downpipe, a rise in ground level, a wall re-pointed in cement or a general lack of maintenance) moisture will move to different areas of the wall and monument, binding with it these soluble salts. The destructive pressure of subflorescence (crystallization below the surface) may cause the surface of the stone to be blown off. Efflorescence (crystallization on the surface) damages the pores and stone surface. Finely carved areas are most likely to be damaged having a large surface area for evaporation.

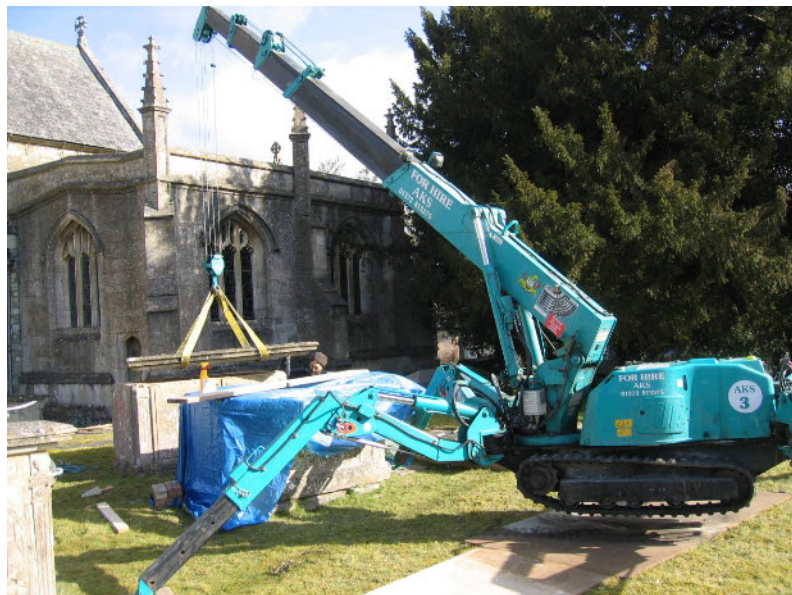
Above: One of 20 box tombs conserved by Minerva at West Lavington, Wiltshire

Where a large slab is supported by the core or side masonry of a box tomb, and repair or cramp removal is necessary it may be lifted by a conventional gantry and block and tackle, which may also be fixed to a scaffold arrangement.

A portable crane is the most efficient method for lifting. These are self propelled and some

only 600mm wide which makes them particularly useful during dismantling and rebuilding as they will also fit into internal spaces. Typically the slabs may weigh anything up to 700kg. Prior to dismantling, facing up surfaces with a system of protection using acid-free tissue will help to protect painted surfaces or friable stone until it has been conserved.

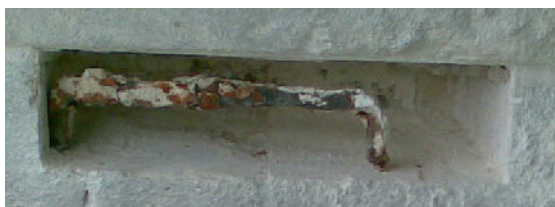
Cramp Removal

Cramps will have been fixed into a recess cut into the stone using either lead or shellac. If they are observed to be corroding, careful drilling out around the bedding material may be required.

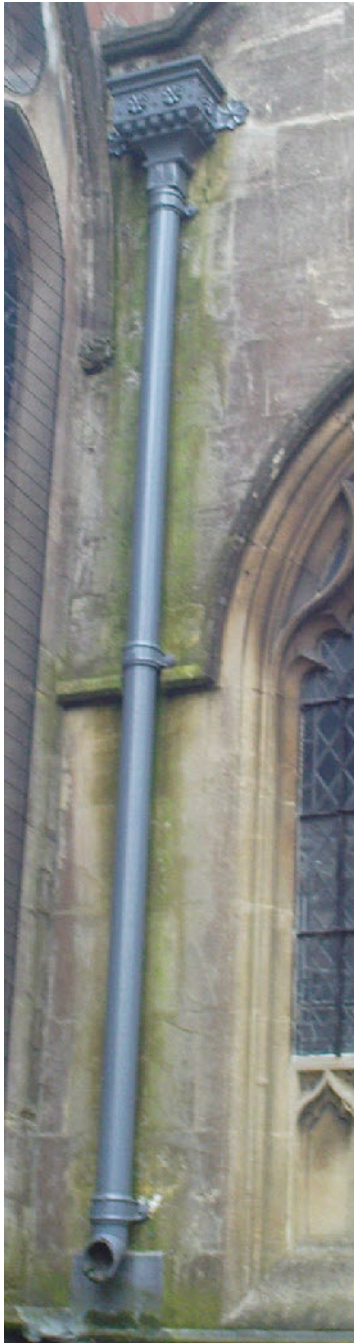
Left: This blocked Victorian downpipe has slowly caused extensive internal and external damage to fabric and consequently the internal monuments by allowing backed up water to enter the church.

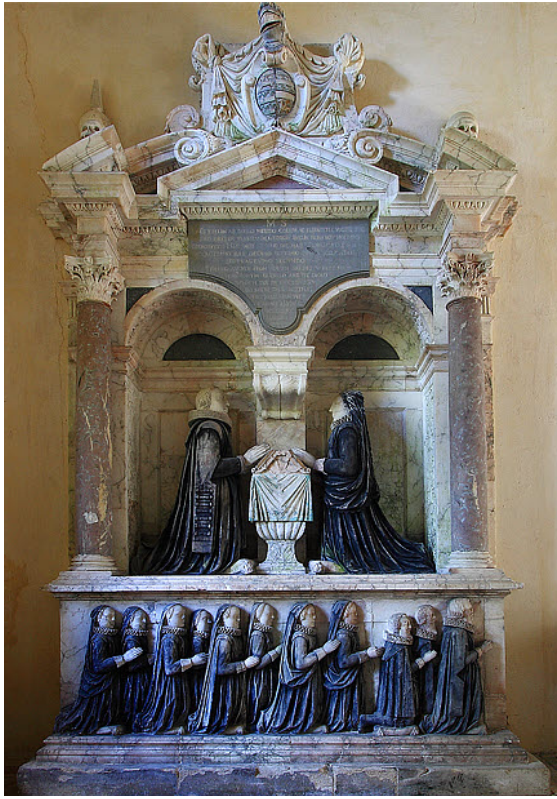
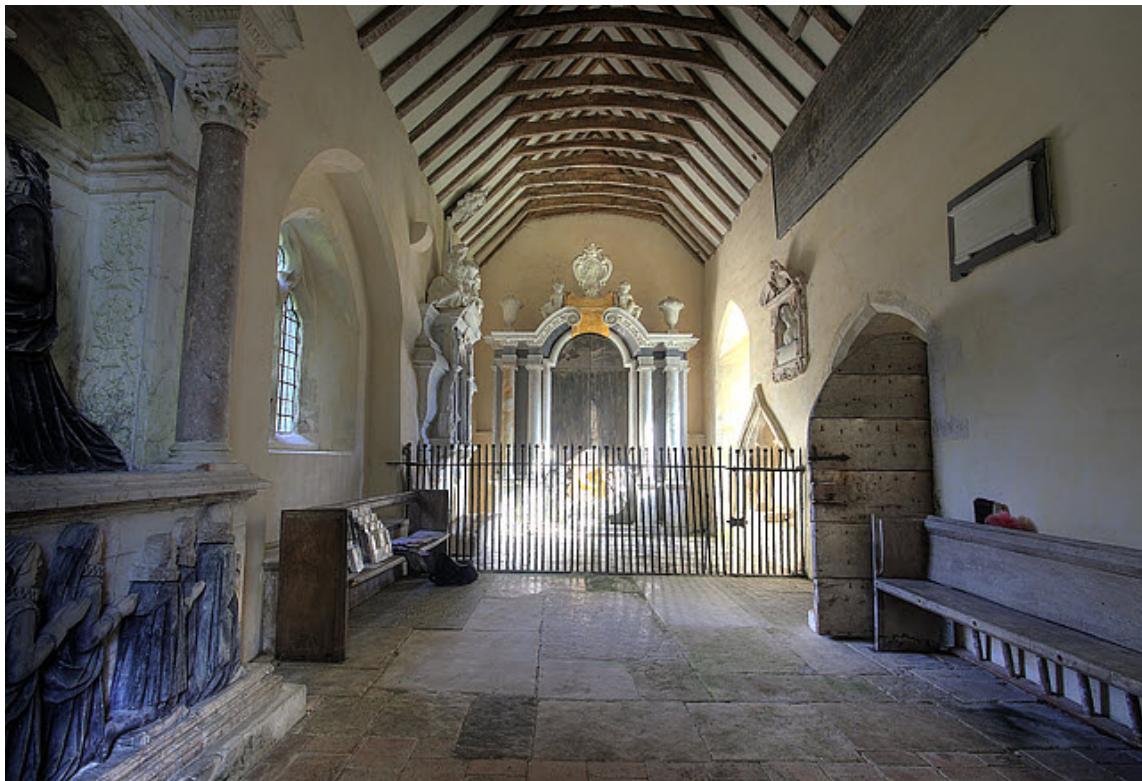
Borbach Chantry, West Dean, Wiltshire

This chapel provides an example of the importance of maintaining the wider environment of the monument. Only minor conservation repairs and pointing were required on these monuments and, after fully boarding them up for protection, we conserved the original plaster surrounding the monuments and re-plastered and repaired adjacent areas. After we had applied several coats of

specially prepared limewash (with a pigment sourced from a local aggregate quarry) we carried out some simple maintenance; replacement of the odd missing roof tile and exterior pointing and redecoration to maintain the safe environment.

The interior of the C14 Borbach Chantry, photos © Copyright Mike Searle

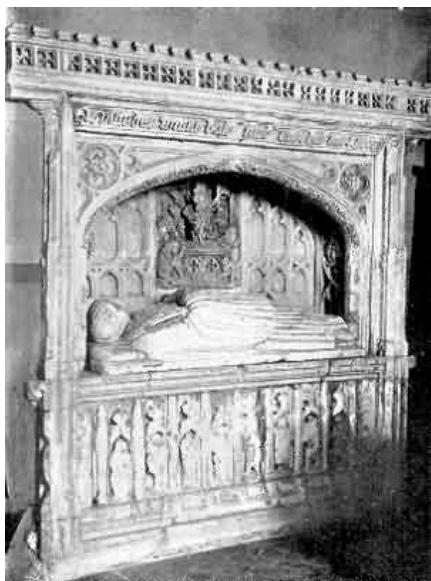
Bryant Monument, St Nicholas and St Cyriac, South Pool, Devon

The monument is to Thomas Bryant, rector of the parish until 1536. He is shown recumbent in cassock, surplice and stole. The monument takes the form of a canopied recess on the north wall of the chancel and shows a resurrection carving within the recess, evidence which would lead to the suggestion that the recess was an Easter sepulchre. The feet of the recumbent figure have been cut off as if to make it fit into the canopy, and there appear to be too few apostles on the plinth below. This would seem to imply that a former Easter sepulchre is being used to house a tomb (rather than the tomb functioning as an Easter sepulchre). After recording, the tomb was fully dismantled and isolated from the external wall by a new lead damp proof membrane. Individual elements were desalinated and the substantial remains of polychrome paint conserved. The monument was then rebuilt.

After recording, the tomb was fully dismantled and isolated from the external wall by a new lead damp proof membrane. Individual elements were desalinated and the substantial remains of polychrome paint conserved. The monument was then rebuilt.

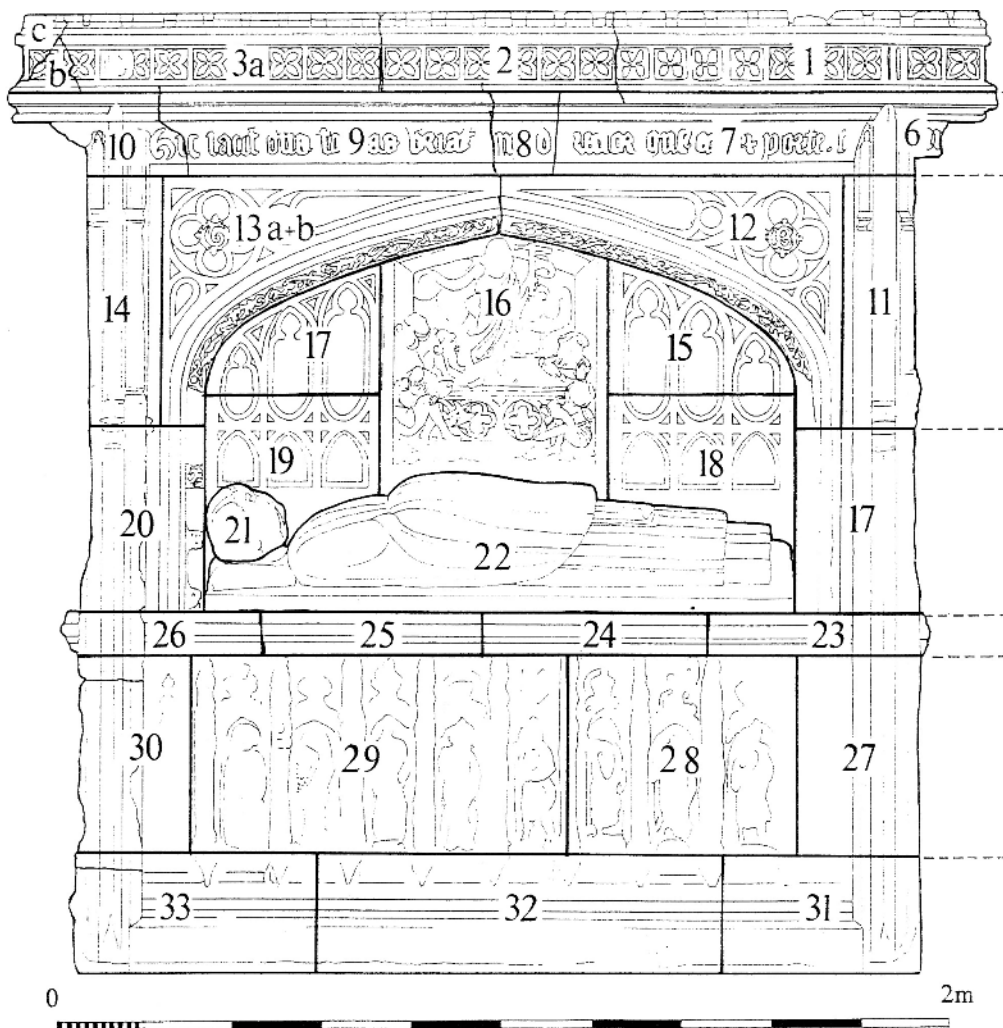
Scale drawing of monument showing composition of stone elements numbered in sequence of dismantling, as recorded by us prior to conservation in 1993.

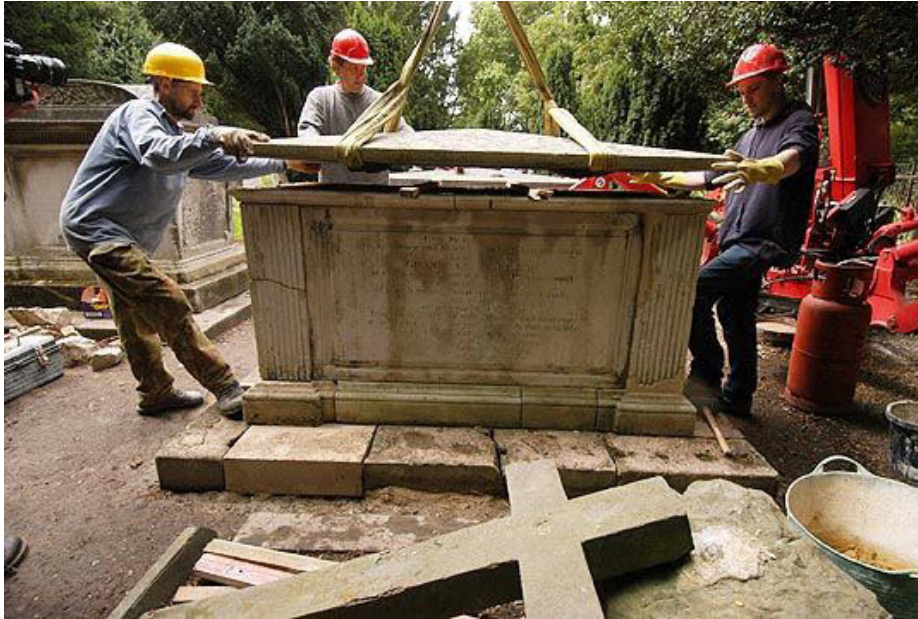
Above: the top slab craned back into position

We found this Grade II listed tomb was in a very poor condition. The Portland limestone was suffering from subsidence within the vault, from acid rain and from rusting cramps. Pressure from the cramps had badly fractured the ledger panels and fluted corner pilasters. Once we had taken the tomb apart and rebuilt collapsing areas of the vault we could repair much of the original stonework *in situ* and refixed using stainless steel cramps and micropins, new fluted elements had to be re-carved and reinstated. We also cut a new, sensitively-placed commemorative plaque.

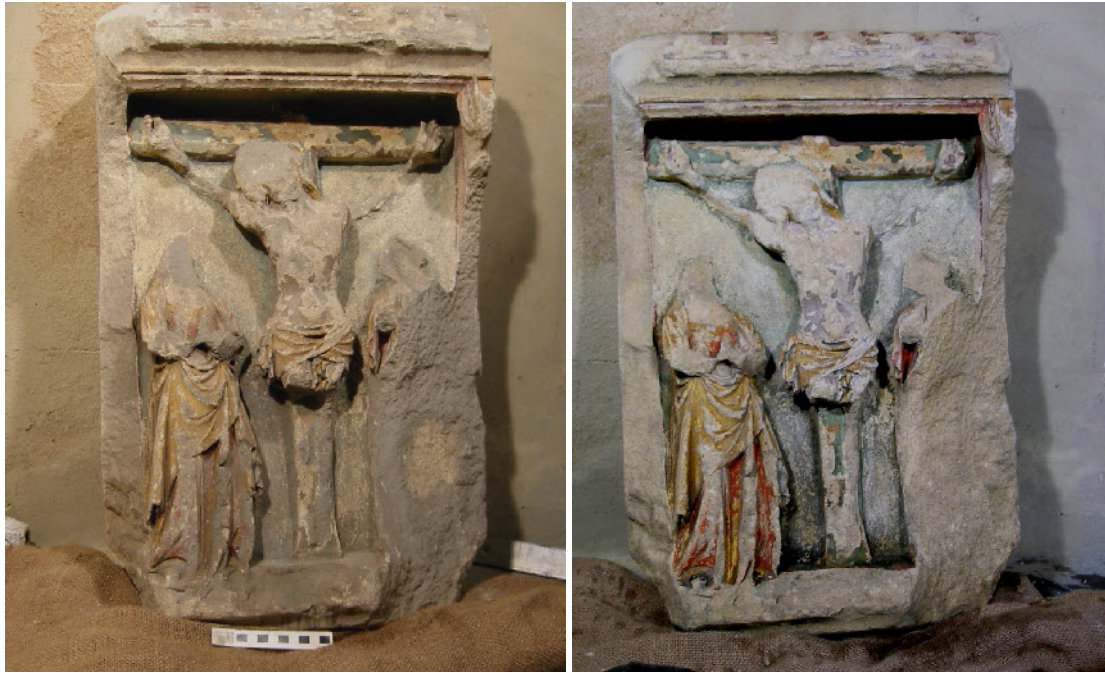
St Margaret of Antioch, Leigh Delamere, Wiltshire

The remarkable 15th century rood fragment was hidden for many years under the pews of the church (the word rood is derived from the Saxon word rood or rode, meaning cross and is associated with the rood screen which would have separated chancel from nave).

At St Margaret's the rood screen has disappeared but this valuable object gives us a glimpse as to what its quality would have been. It was highly decorated, so after recording and gentle cleaning the polychrome decorative scheme was conserved. The rood was then placed in a speciallymade lead case to protect it from any water ingress and fixed into its newposition adjacent to the chancel.

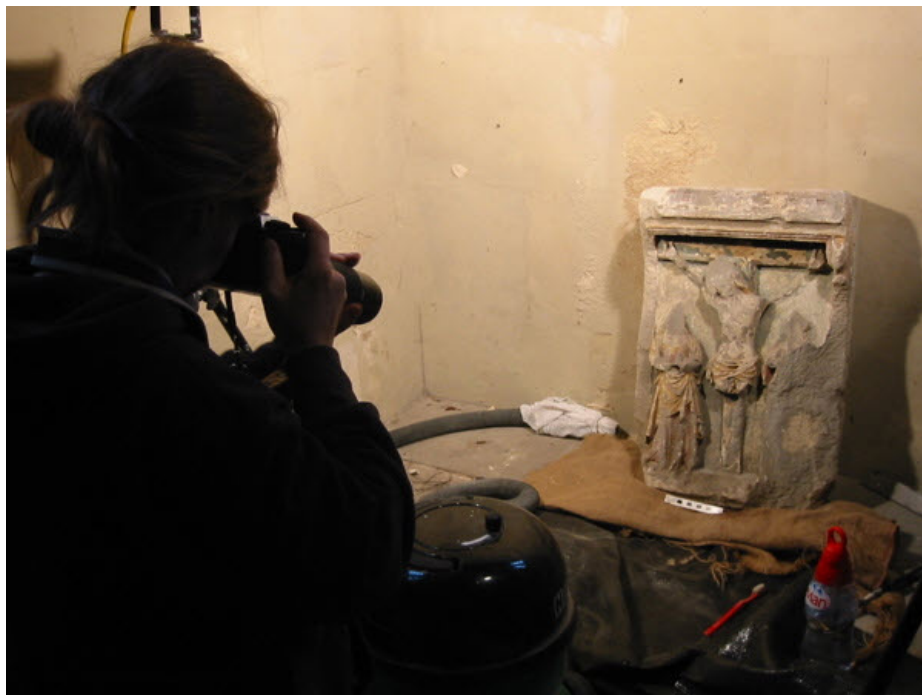
Recording prior to trial cleaning and conservation
